THE IMPACT OF CATTLE FEEDLOT  
OPERATION ON GROUNDWATER  
QUALITY IN THE FRACTURED  
ROCKS NEAR THE WIARTON  
SEWAGE LAGOON

THE IMPACT OF CATTLE FEEDLOT OPERATION  
ON GROUNDWATER QUALITY  
IN THE FRACTURED ROCKS NEAR THE  
WIARTON SEWAGE LAGOON

by  
Blagoje Novakovic, P.Eng.

SOUTHWESTERN REGION  
TECHNICAL SUPPORT SECTION  
LONDON

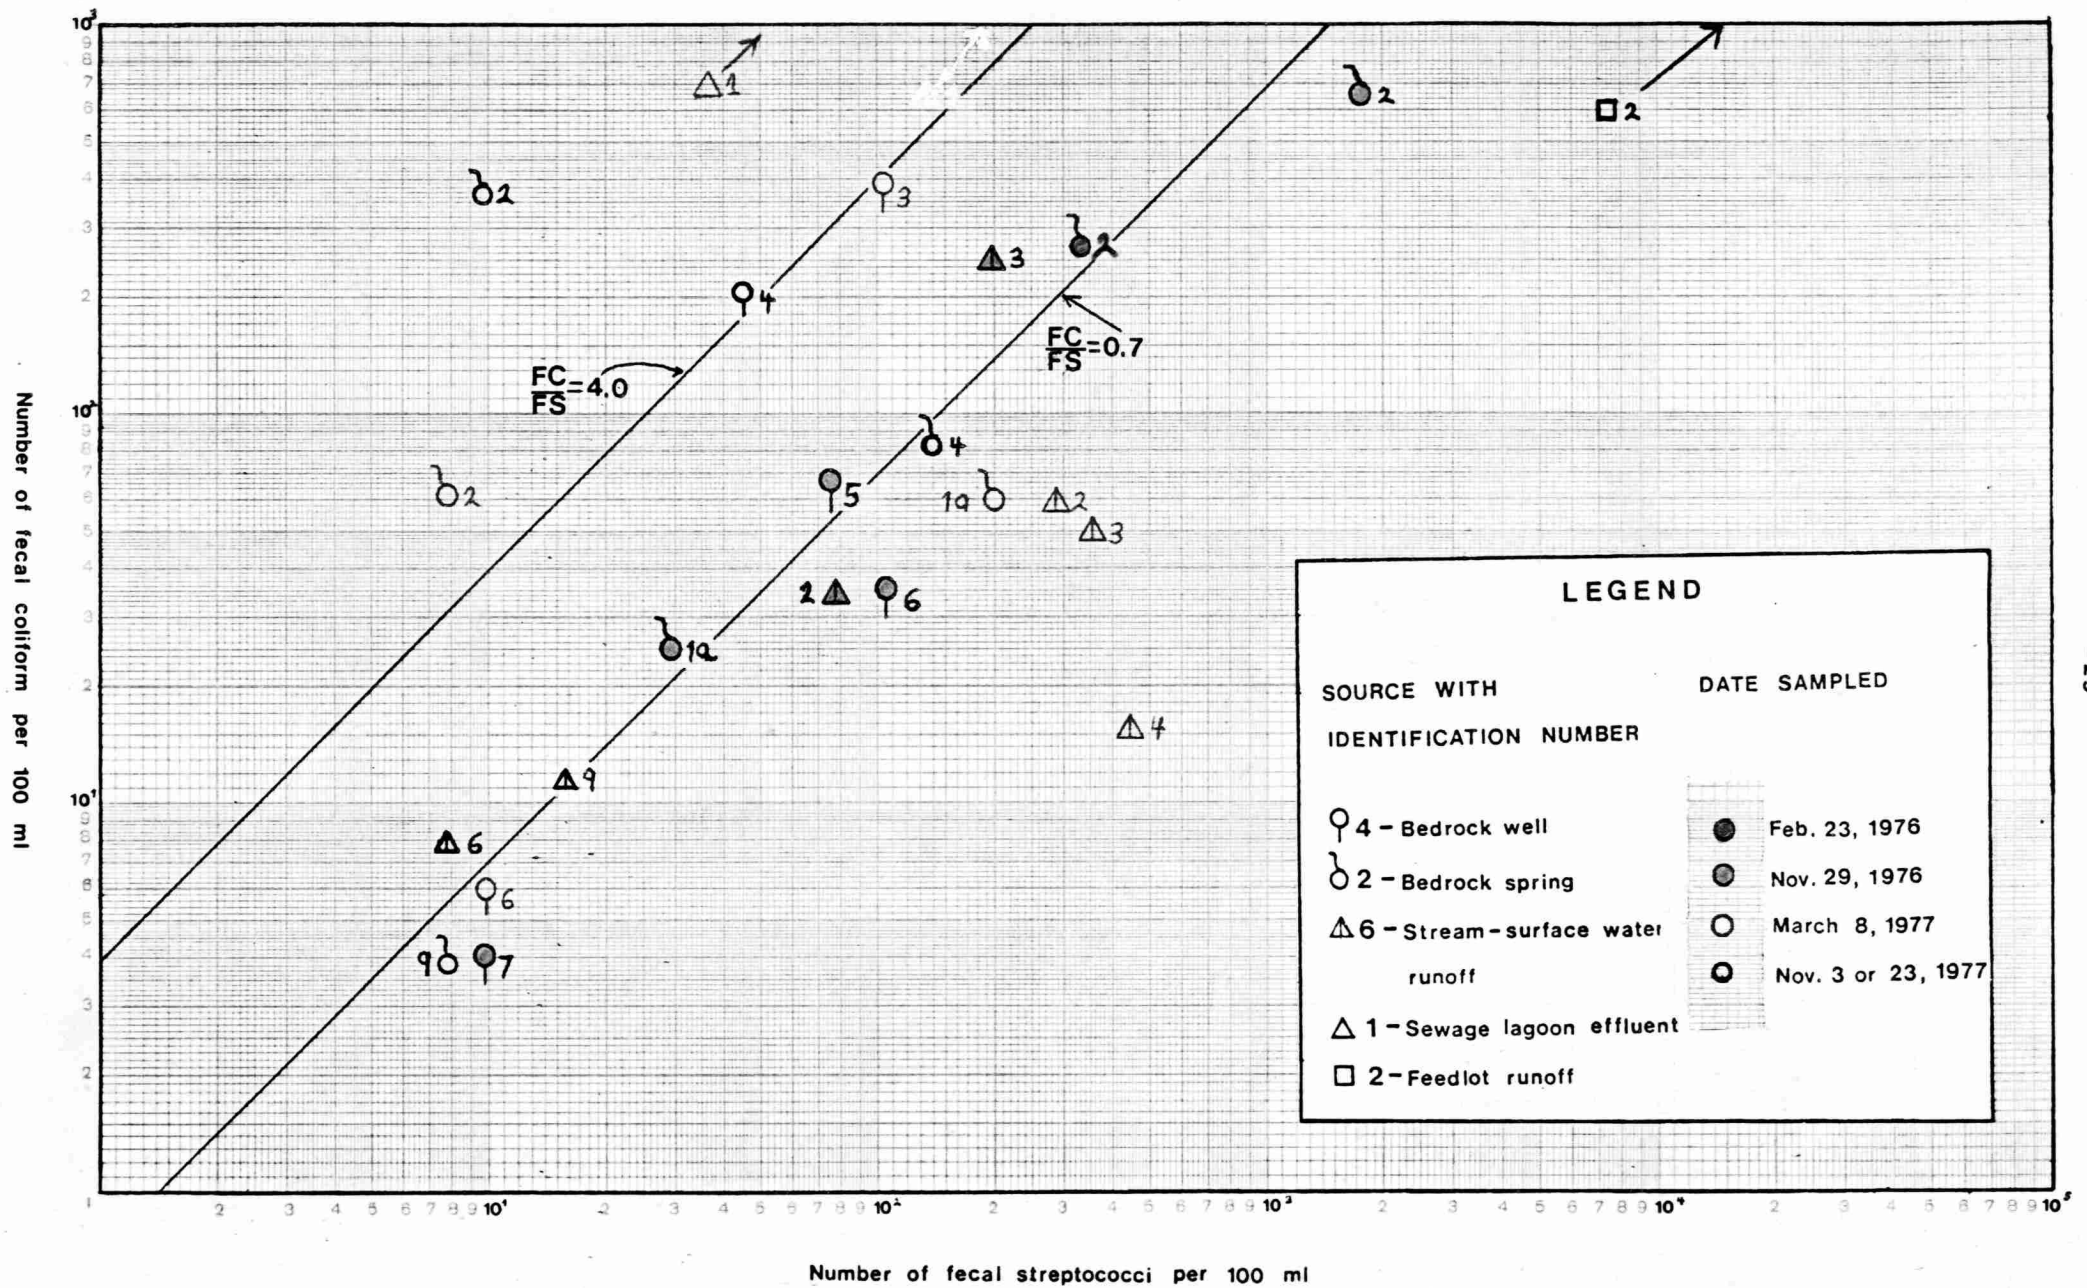
FIGURE 9. FECAL COLIFORM CONCENTRATIONS COMPARED TO FECAL STREPTOCOCCI CONCENTRATIONS IN SAMPLED SOURCES IN THE STUDY AREA.

In Figure 9, the FC concentrations are plotted against the FS concentrations for each sample (for four sampling dates) in which bacterial colonies were detected. These included five different sources totalling 23 samples. Of the 23 samples, only four had FC:FS ratios greater than 4.0 suggesting a human source. Twelve had FC:FS ratios which were less than 0.7 suggesting animal sources. This technique is subject to numerous variables and is used here in an effort to gain a general understanding of the problem. However, it should be noted that the sewage lagoon effluent and feedlot runoff do fall into the  $>4.0$  and  $<0.7$  categories respectively as this methodology suggests they should.

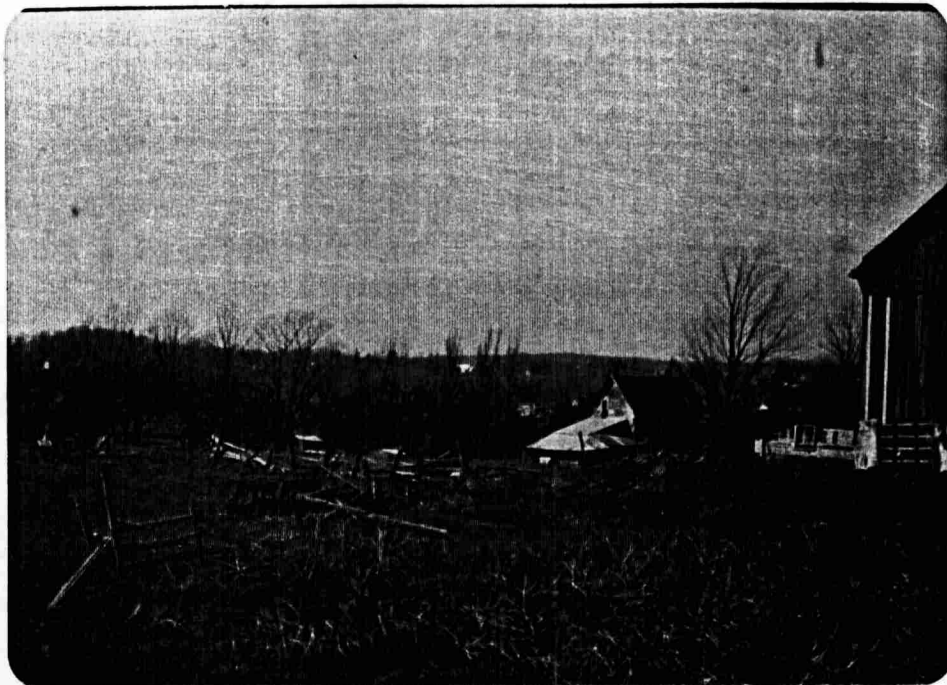
Plate 7. Looking northwest; the manure pile is located immediately beside the intermittent stream. The outhouse is slightly left of centre (shed) while the Armstrong springs are beyond the building on the left.

The contributions to the deterioration of water quality in the Armstrong springs from the two other nearby potential pollution sources (C and D in Figure 4, Plate 7) are difficult to assess accurately at this time. However,

3. The manure piles at pollution source D (Figure 4, Plate 7) should be removed taking appropriate measures to prevent pollutants associated with this operation from infiltrating into the fractured bedrock and from entering the nearby intermittent stream.
4. Wastes in the outhouse (source C in Figure 4) should be isolated and prevented from entering the fractured bedrock.

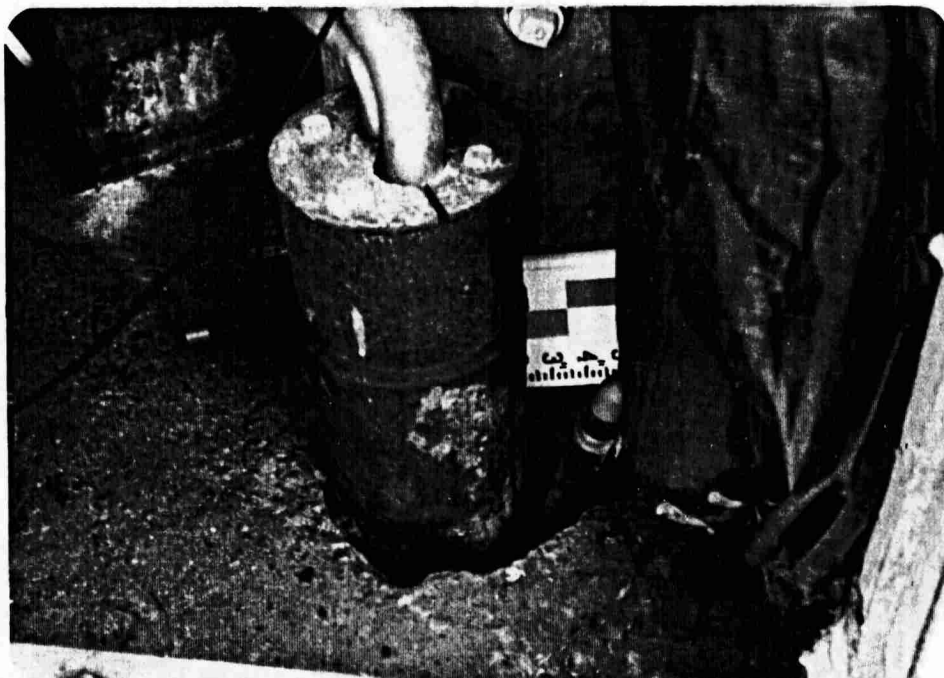
Plate 8. Although housed in the small pumphouse and protected from frost, the well serving the Hurlburt family (well 5534) is unsatisfactorily completed. The annular space between the drill hole and well casing has been left ungrouted.

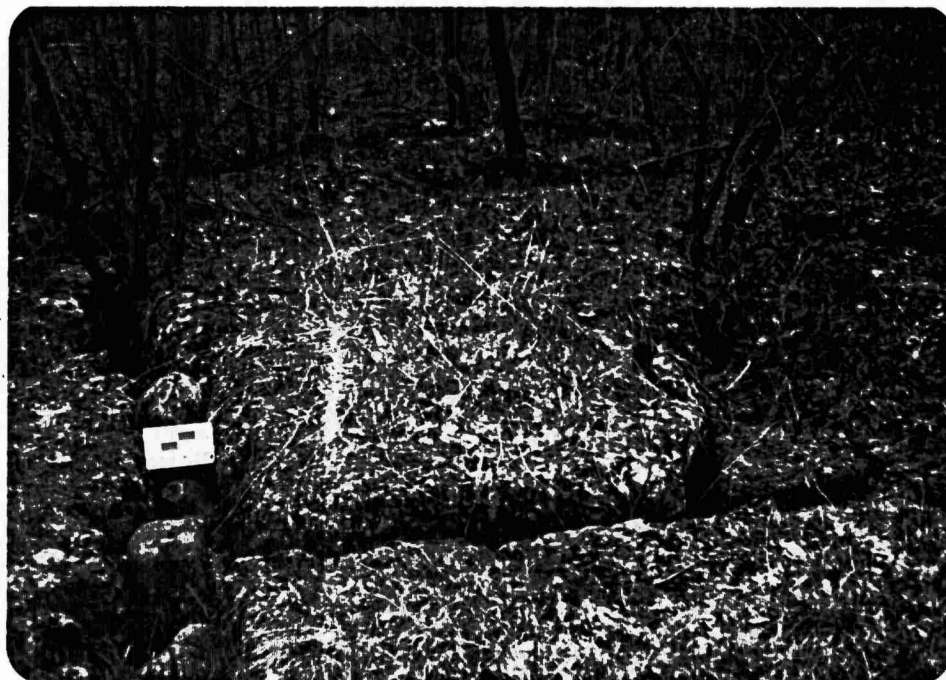
Plate 10. Vertical crevasses and fractures are commonly found in the exposed dolomite. The main fracture patterns here are from NE to SW and from NW to SE.

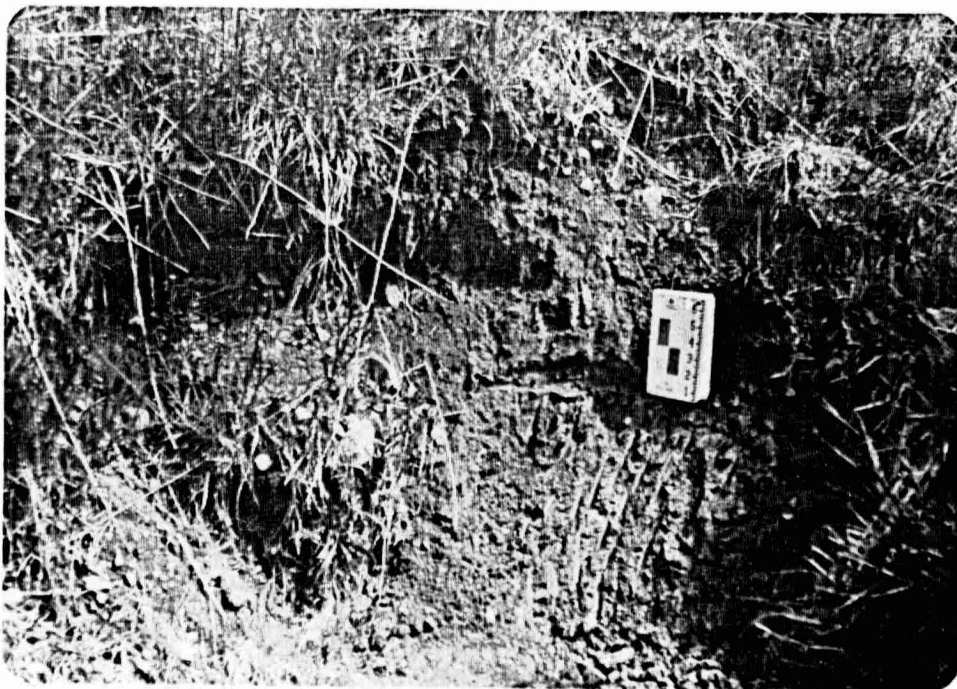
Plate 11. Erosion has exposed silty clay till deposits overlain by a thin veneer of silt, sand, and gravel. Point at the northeastern corner of the Wiarton sewage lagoon.

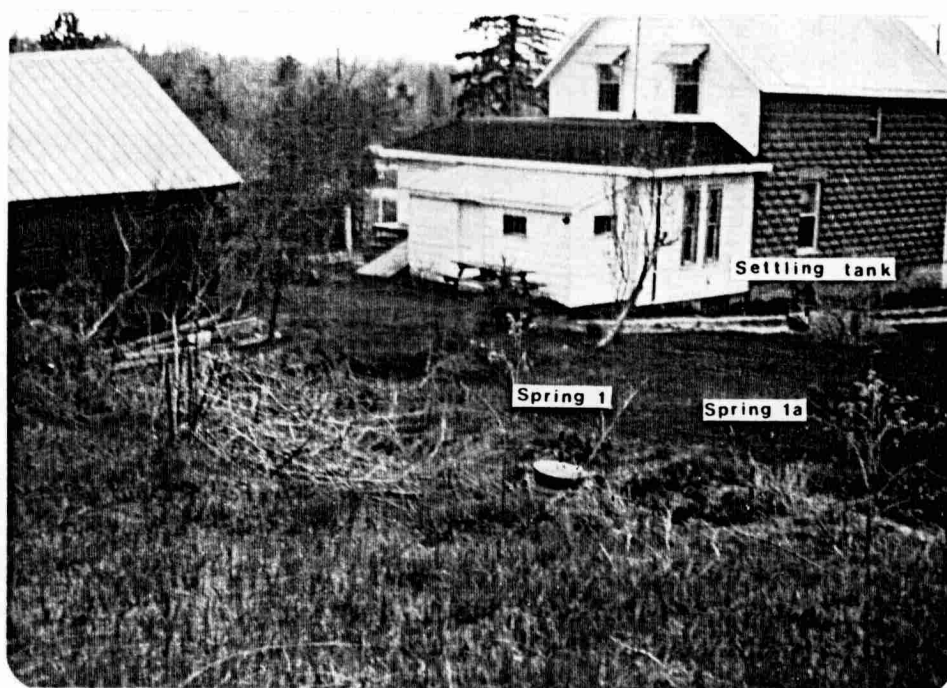
Plate 12. Looking northwest; the erosion channel which originates at the Armstrong springs and which has been developed during high flow from spring 1a.

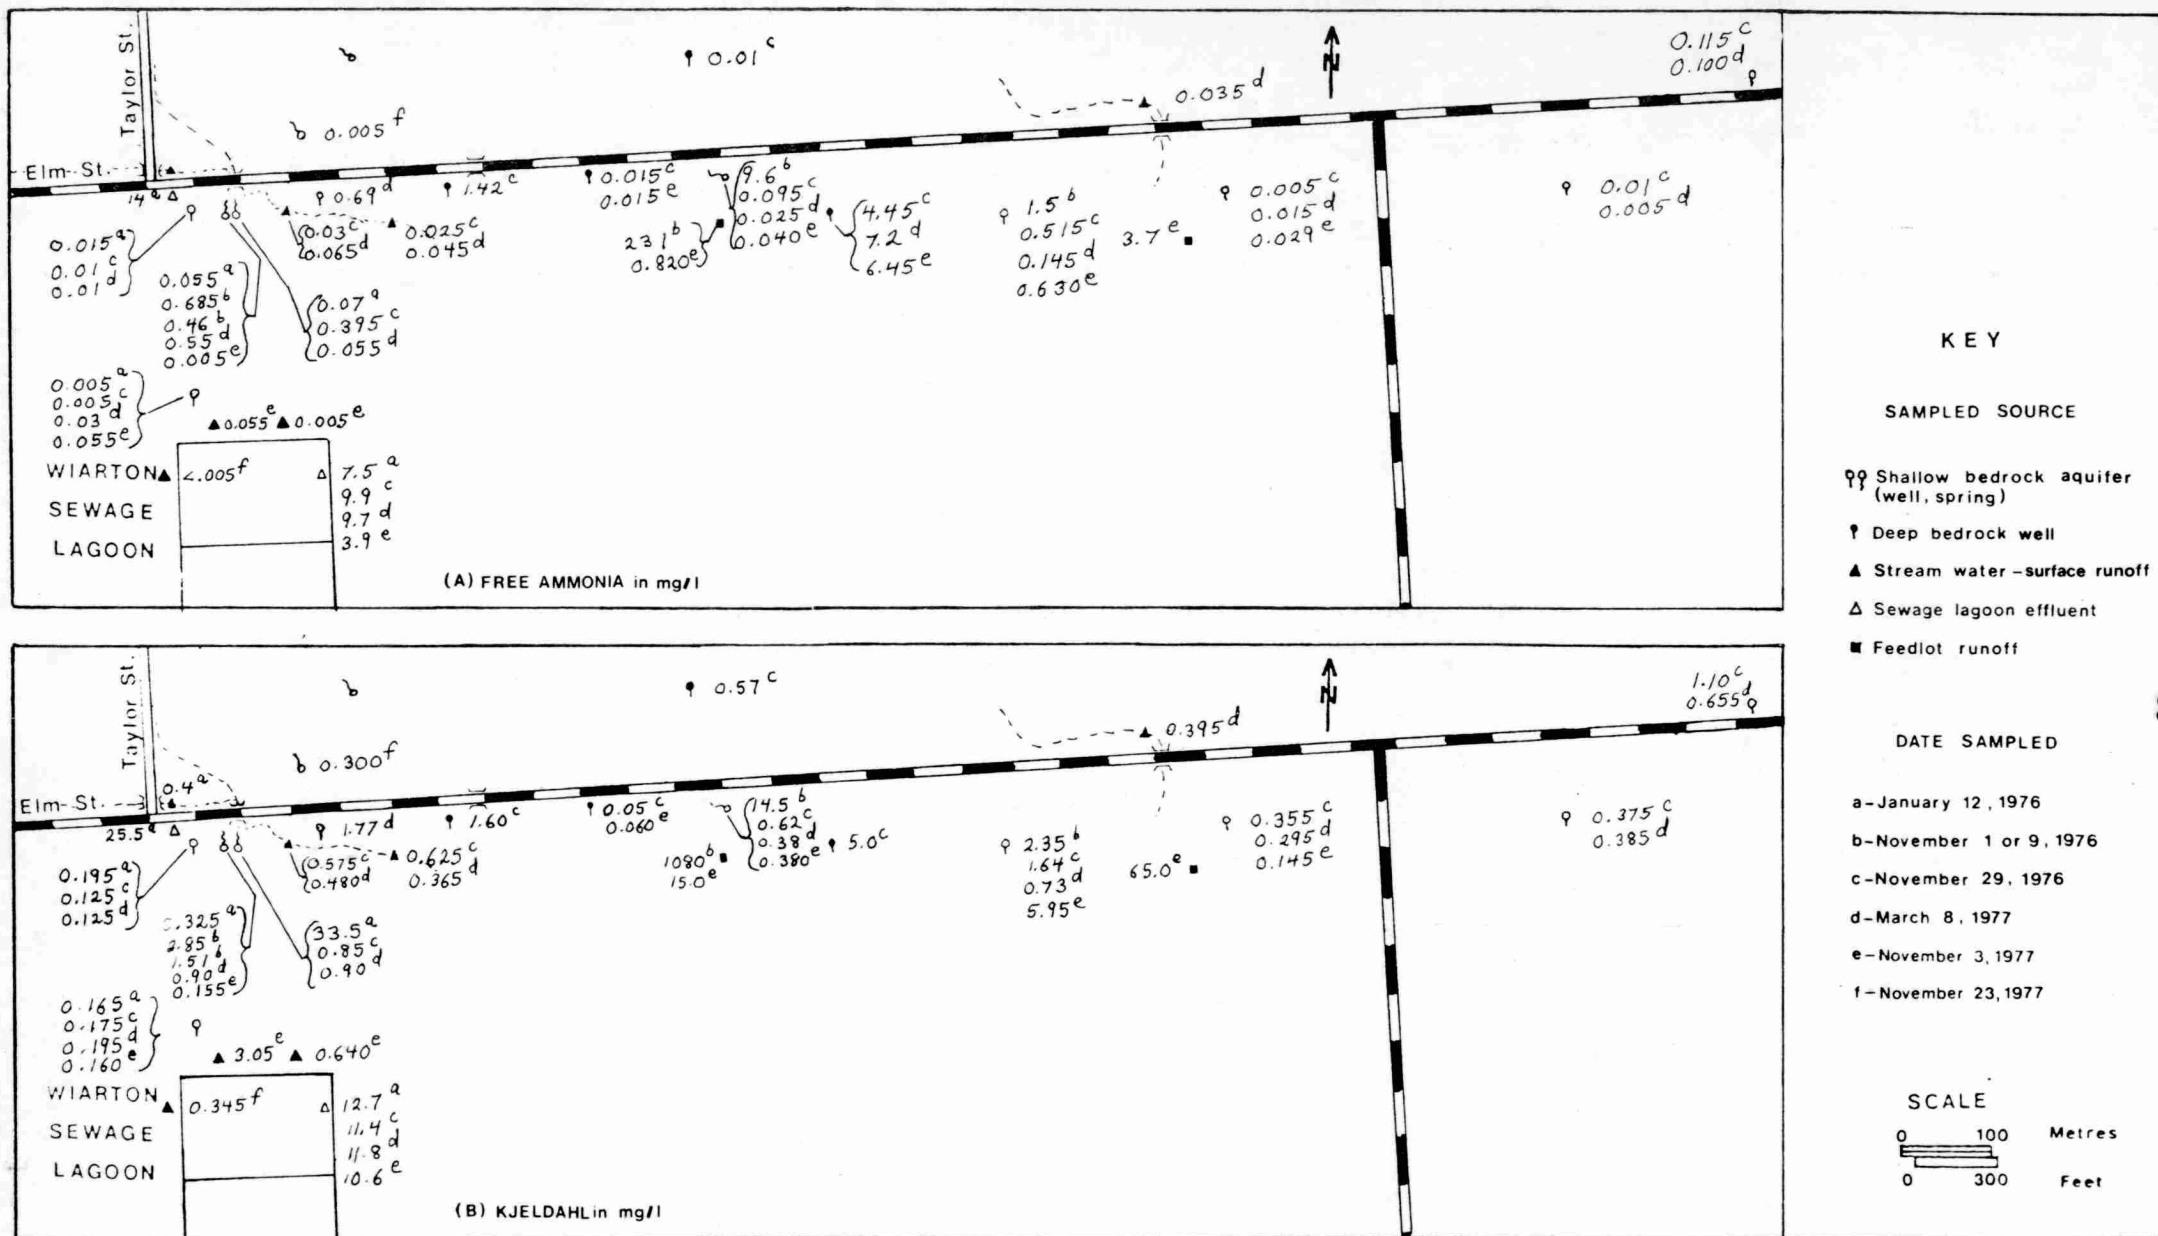
FIGURE 10. HYDROCHEMICAL MAP OF FREE AMMONIA (A) AND KJELDAHL (B) DISTRIBUTION IN GROUNDWATER, SURFACE WATER AND FEEDLOT RUNOFF.

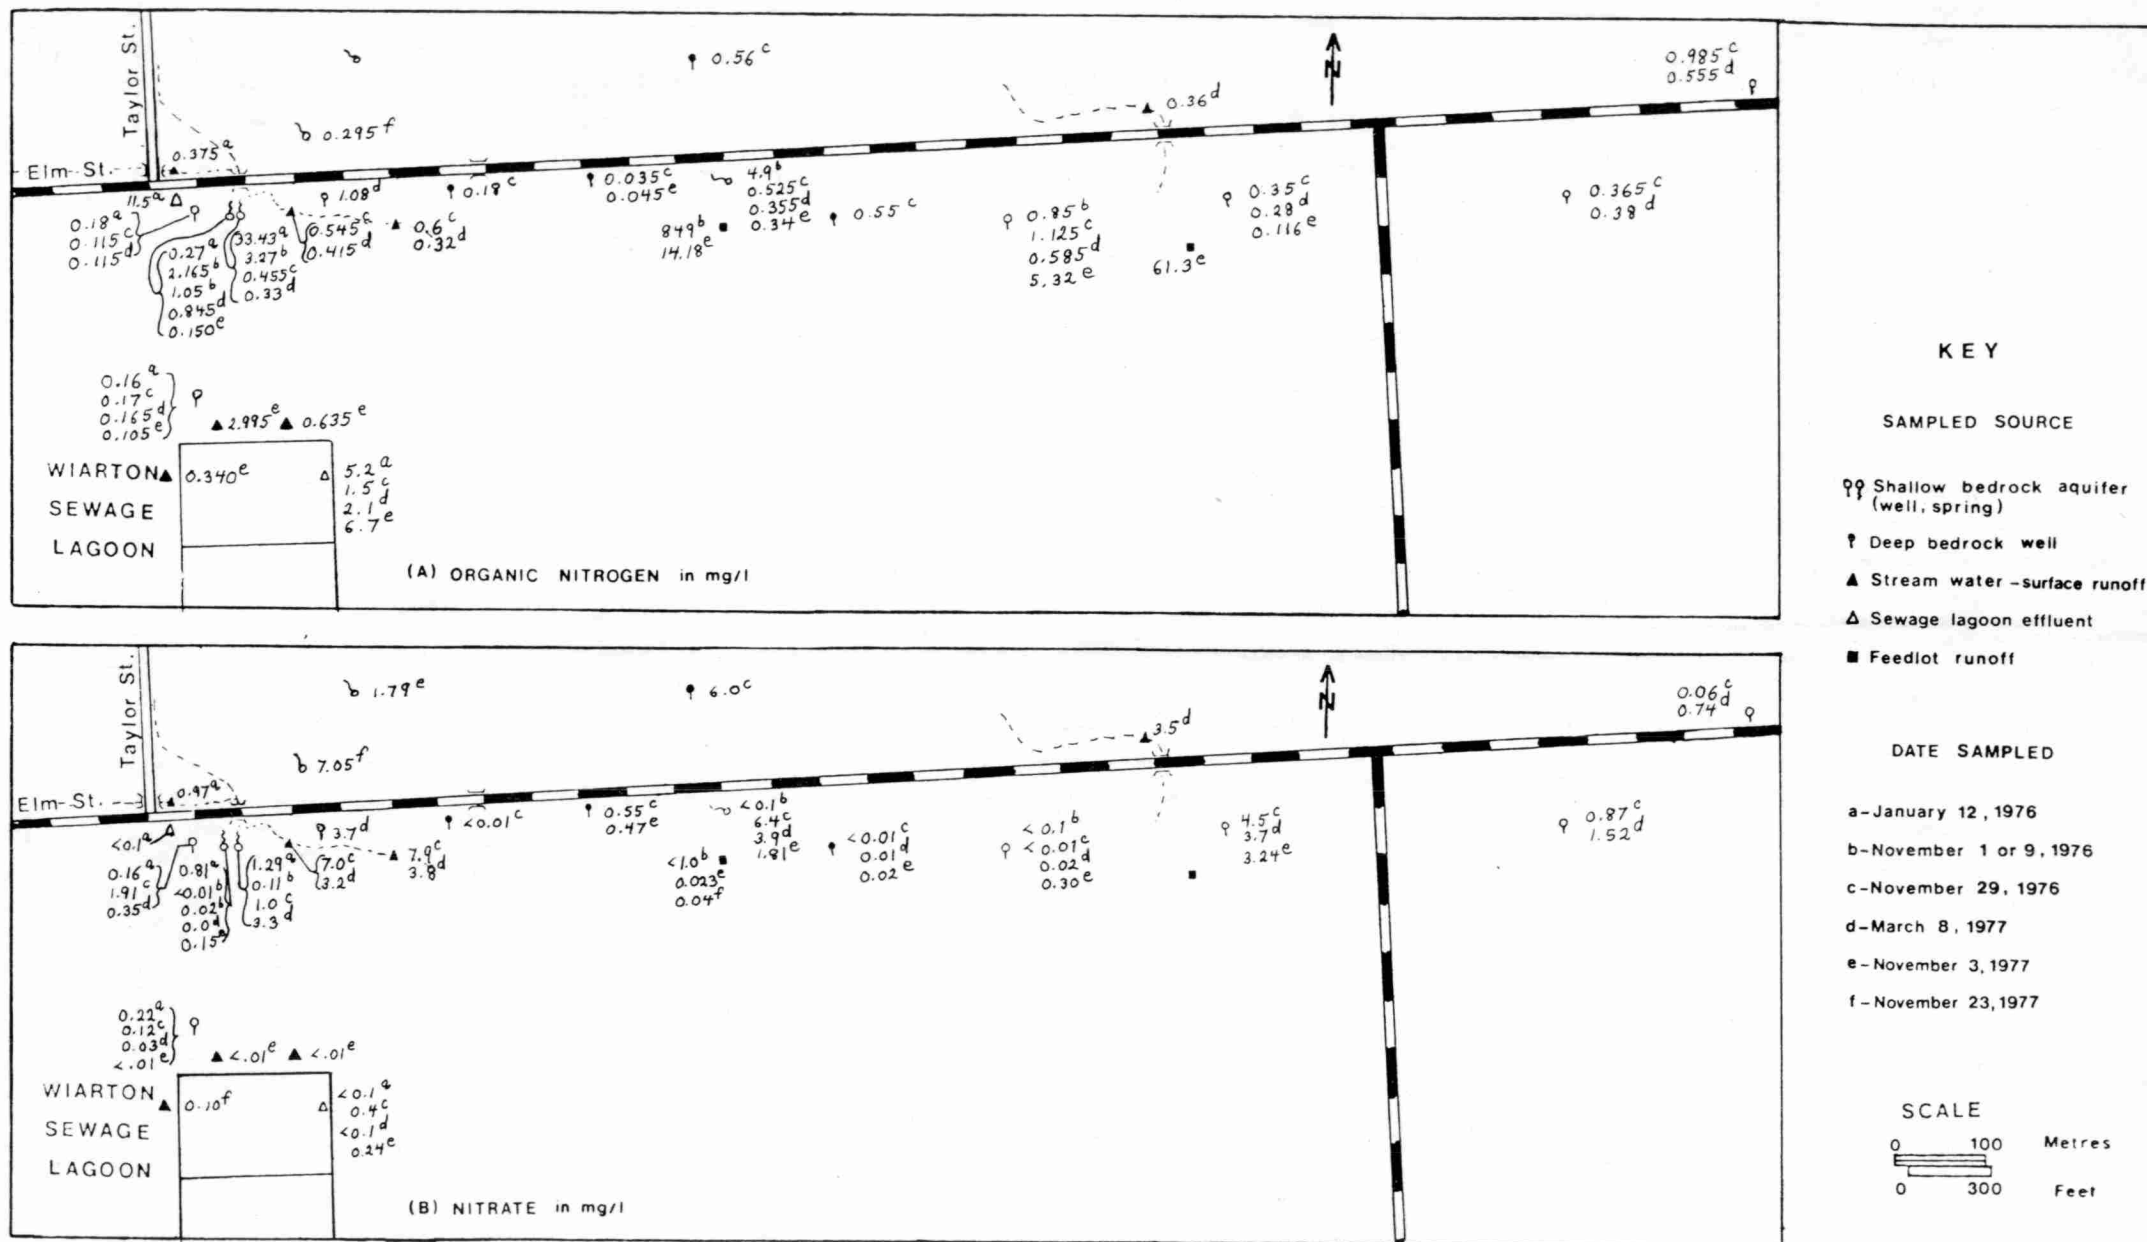
FIGURE 11. HYDROCHEMICAL MAP OF ORGANIC NITROGEN (A) AND NITRATE (B) DISTRIBUTION IN GROUNDWATER, SURFACE WATER AND FEEDLOT RUNOFF.

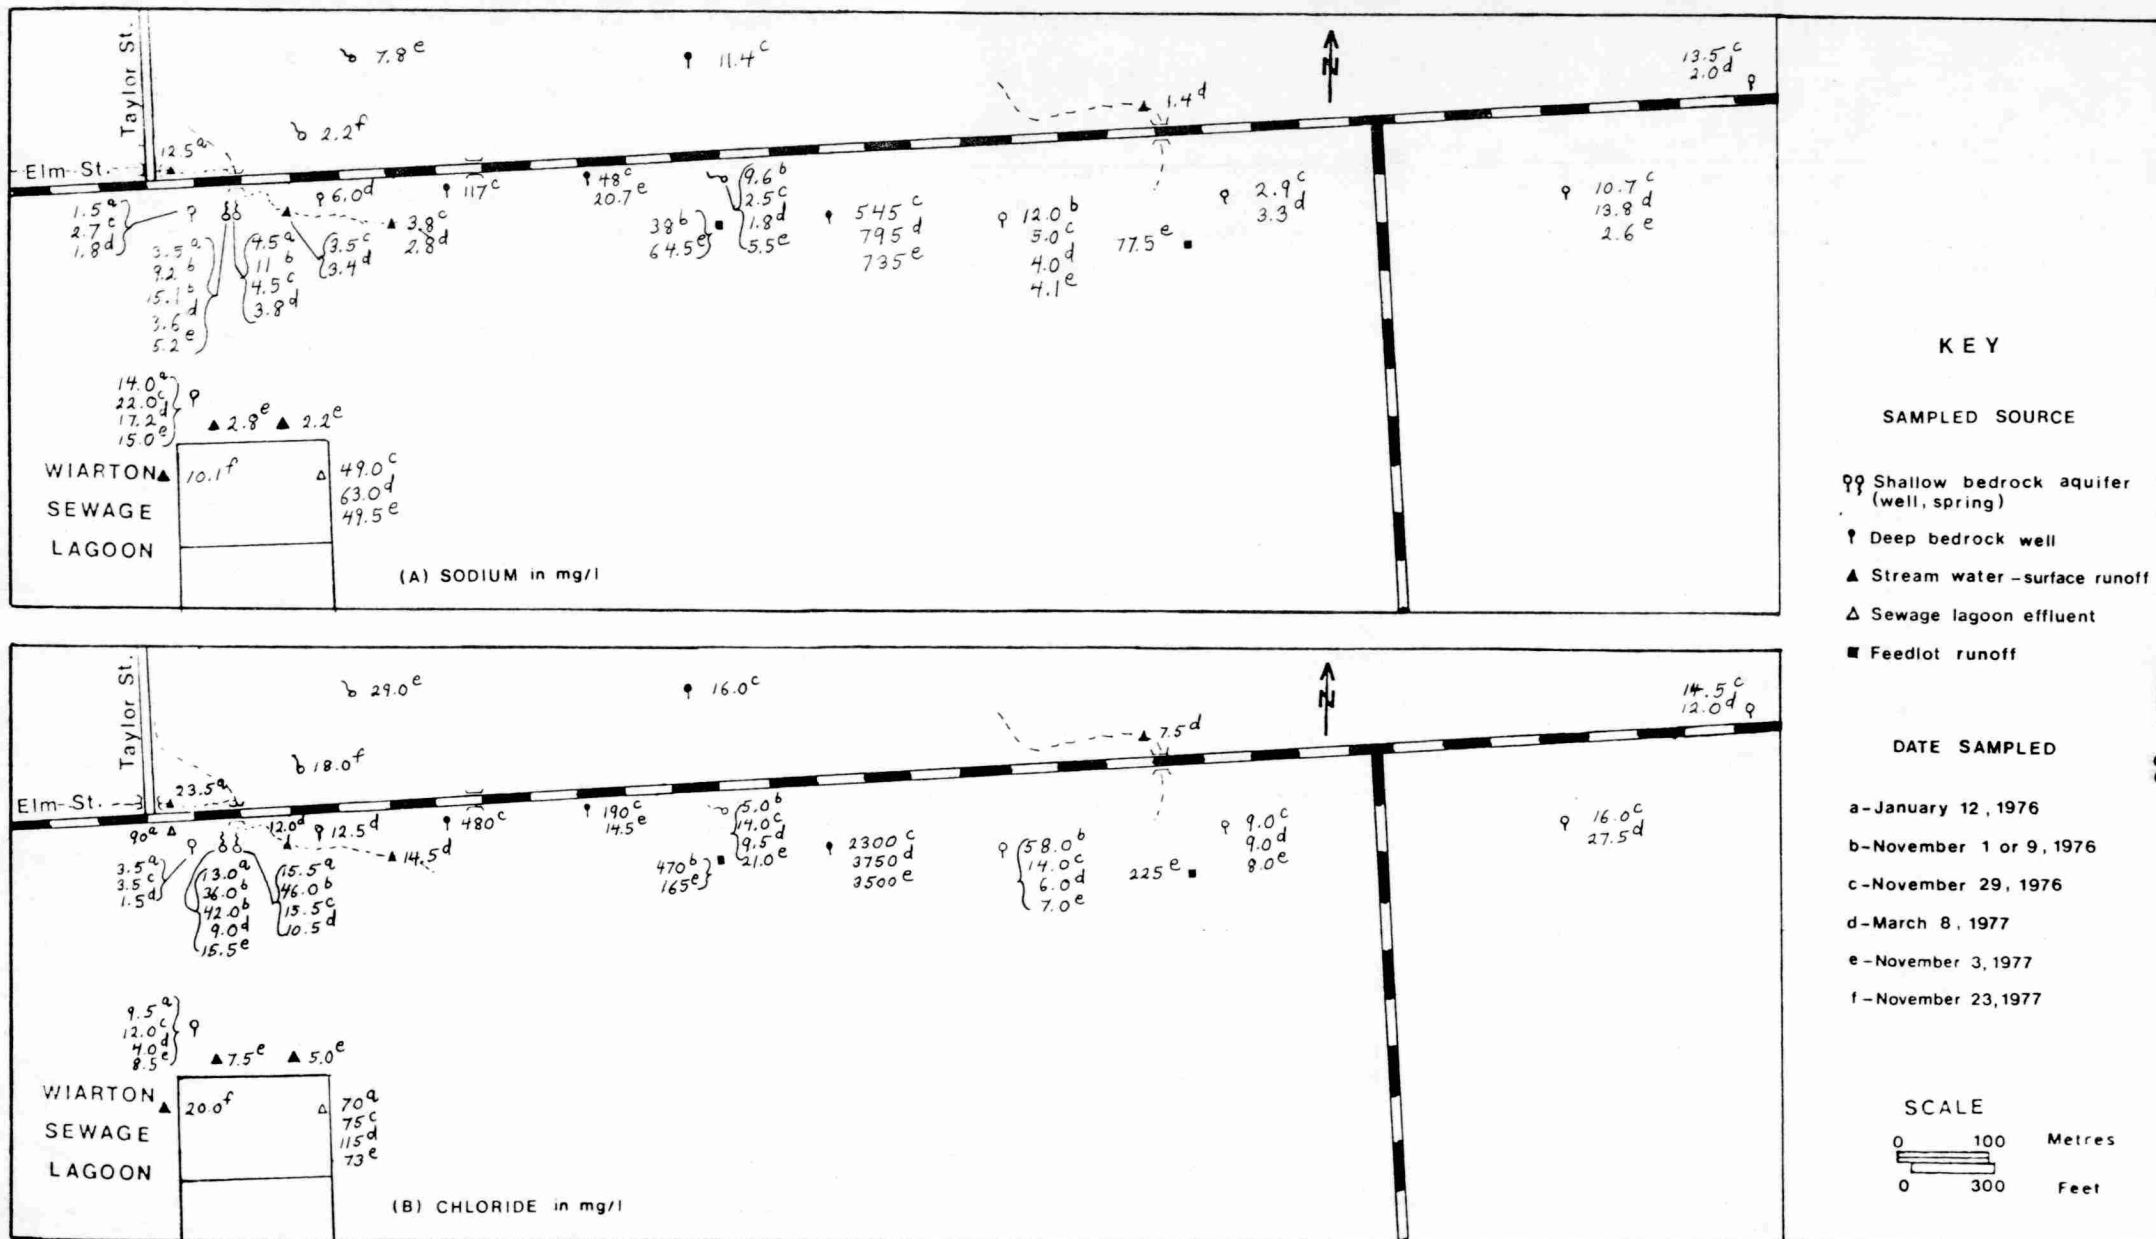
FIGURE 12. HYDROCHEMICAL MAP OF SODIUM (A) AND CHLORIDE (B) DISTRIBUTION IN GROUNDWATER, SURFACE WATER AND FEEDLOT RUNOFF.

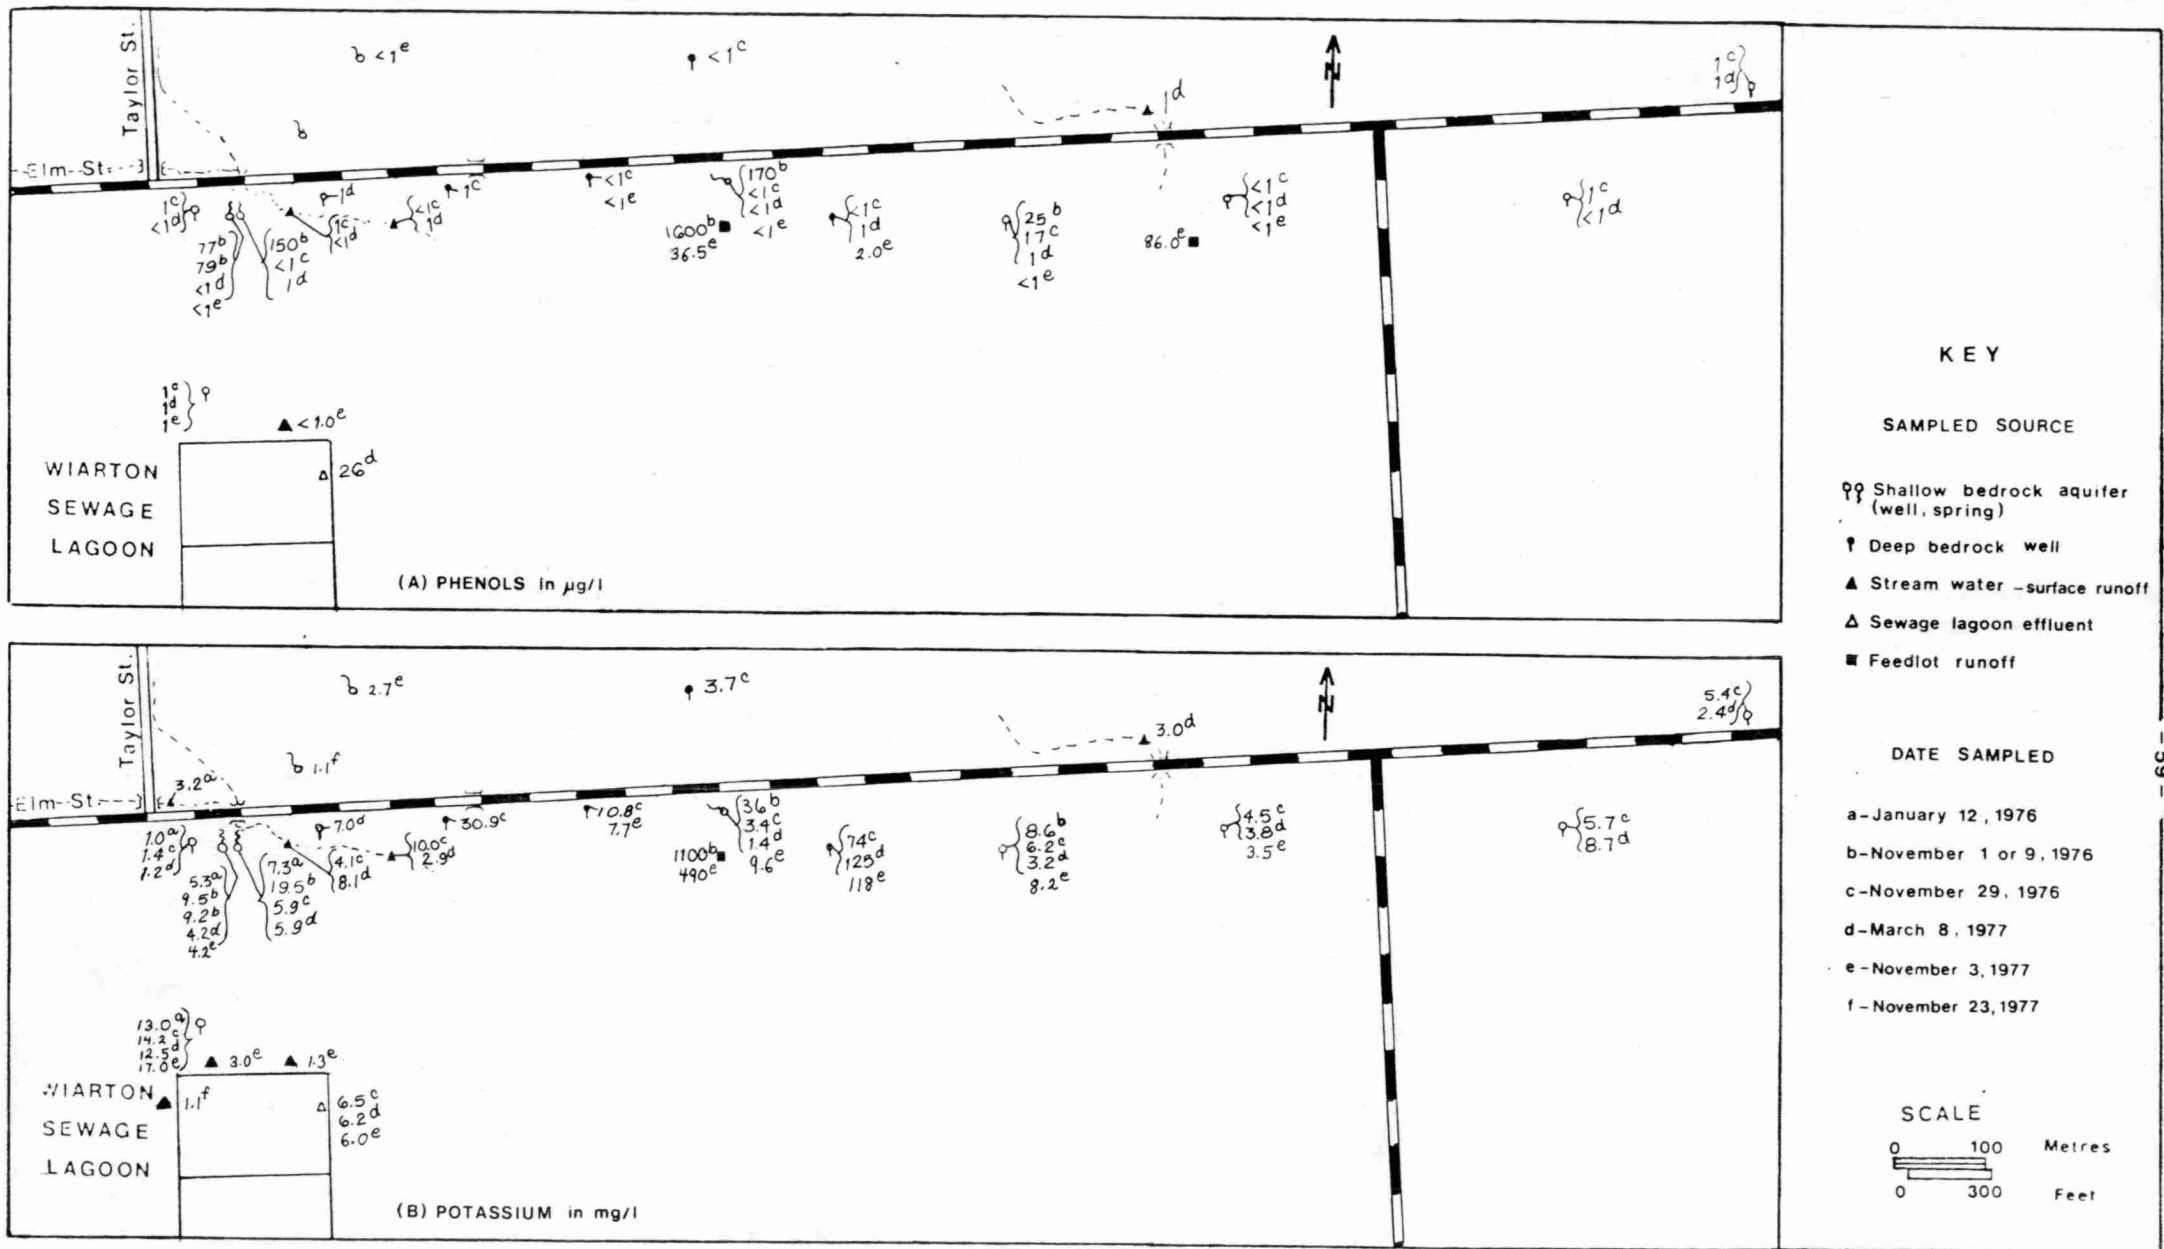
FIGURE 13. HYDROCHEMICAL MAP OF PHENOLS (A) AND POTASSIUM (B) DISTRIBUTION IN GROUNDWATER, SURFACE WATER AND FEEDLOT RUNOFF.

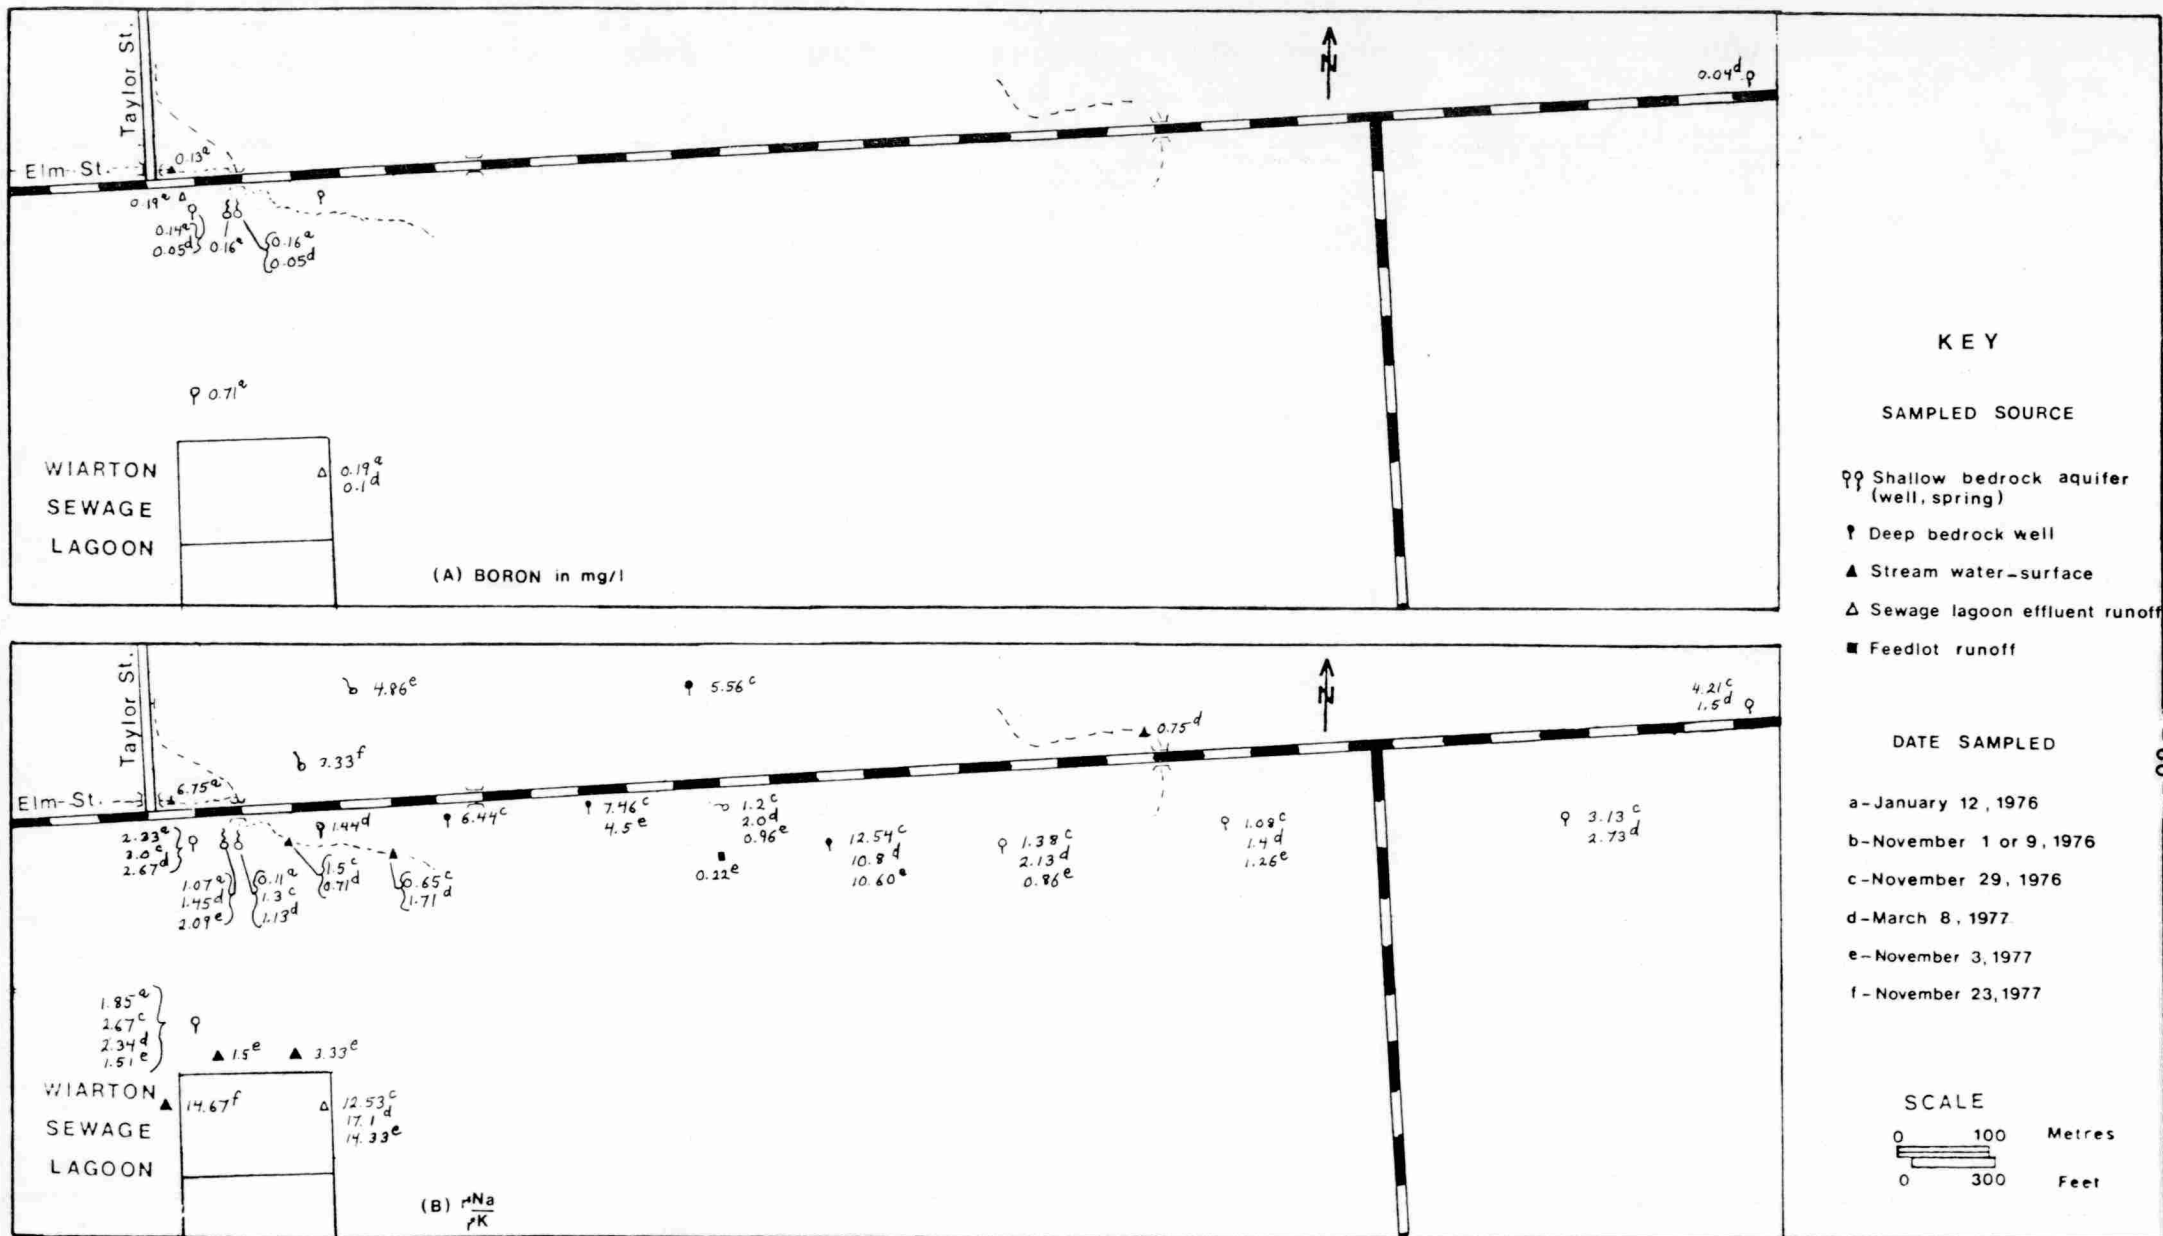
\* The notation r indicates that the ratios are calculated from equivalent parts per million

**FIGURE 14. HYDROCHEMICAL MAP OF BORON (A) AND Na/K RATIO (B) DISTRIBUTION IN GROUNDWATER, SURFACE WATER AND FEEDLOT RUNOFF.**

Another characteristic of water quality contamination in the shallow aquifer is the very low sodium to potassium ratio (Figure 14). This ratio may be used (knowing the general background ratio) as an indicator of pollution.
